Re: DR Horton; Enchanted Hills Subdivision; SIC 1522; NPDES Compliance Evaluation Inspection; NPDES Permit No. NMR10012X; July 19, 2019

NPDES Construction General Permit Inspection Report – State of New Mexico

**Enchanted Hills Subdivision
Construction General Permit (CGP)
Compliance Evaluation Inspection (CEI)**

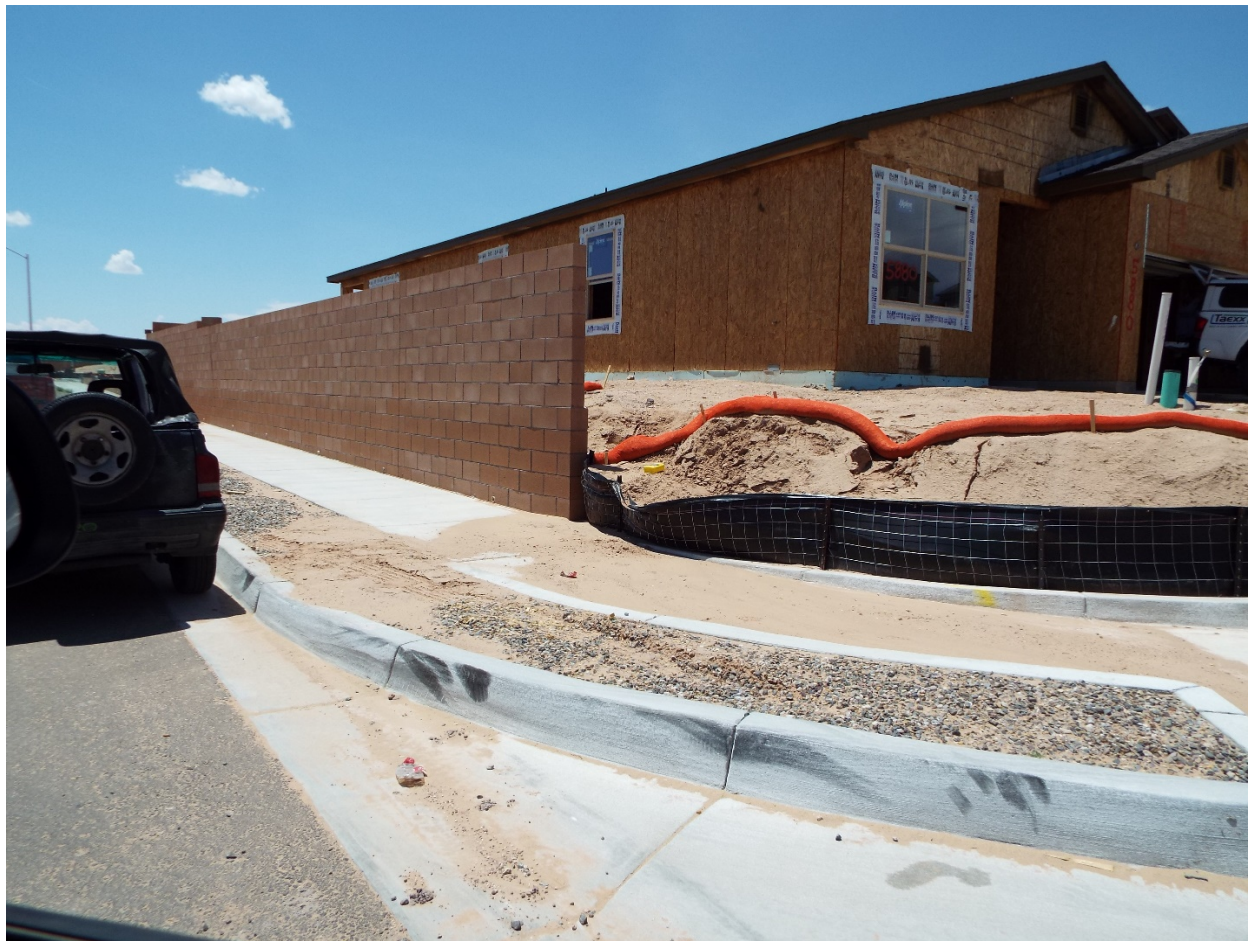
NMED/SWQB
Official Photograph Log
Photo # 1

Some of the silt fences are need of repair and need of cleaning. See photo provided below.

Photographer: Daniel Valenta	Date: July 19, 201	Time: 1319 Hours
City/County: Rio Rancho / Sandoval		State: New Mexico
Location: Enchanted Hills Subdivision / DR Horton Homes; Chayote and Valencia Road		
Subject: Silt fence that needs repair.

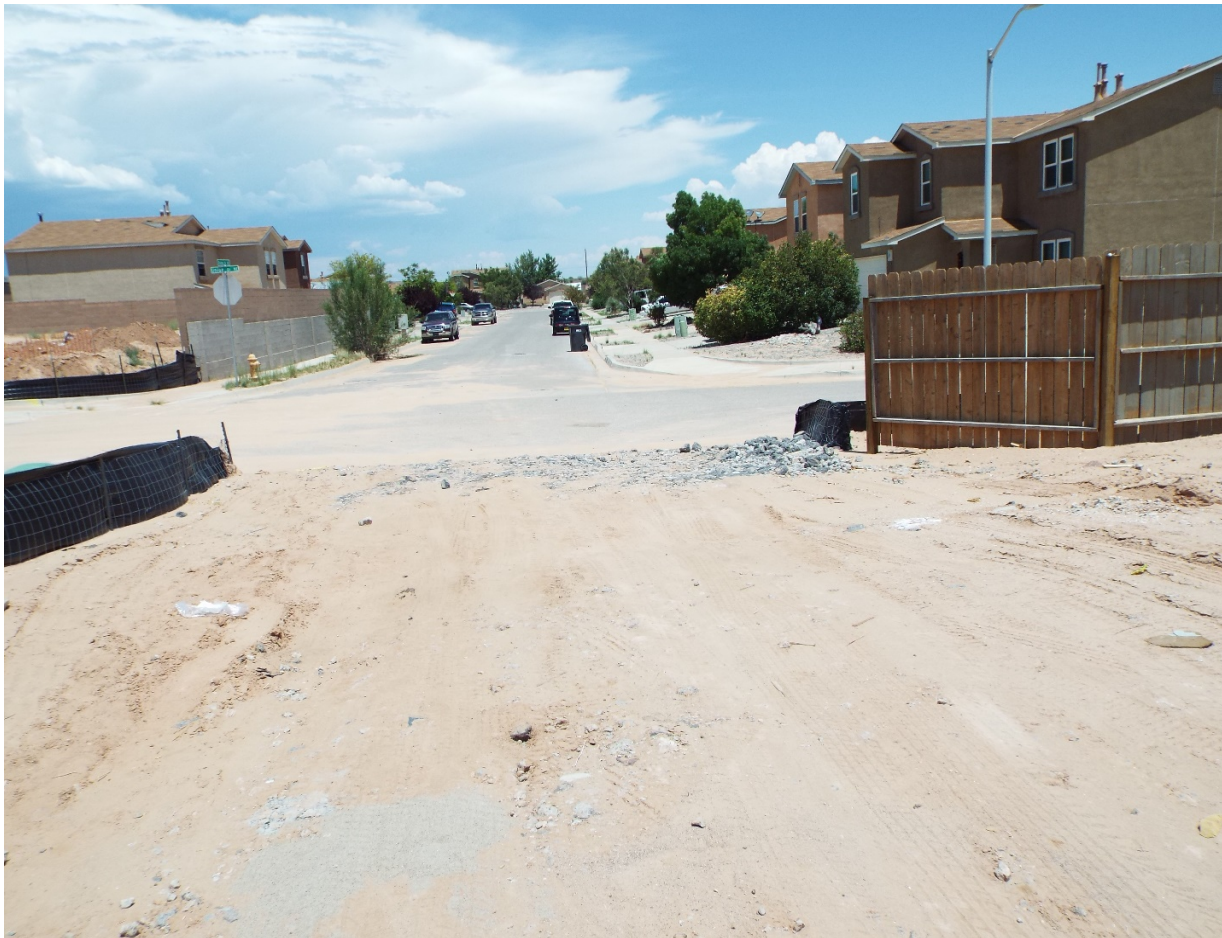
NMED/SWQB
Official Photograph Log
Photo # 2

The site had a dedicated area for a concrete washout along with trash bins. The aggregate was filled with sediment and needs to be cleaned out to prevent track out of additional sediment onto the paved areas of the site.

Photographer: Daniel Valenta	Date: July 19, 201	Time: 1322 Hours
City/County: Rio Rancho / Sandoval		State: New Mexico
Location: Enchanted Hills Subdivision / DR Horton Homes; Chayote and Valencia Road		
Subject: aggregate entrance to street.

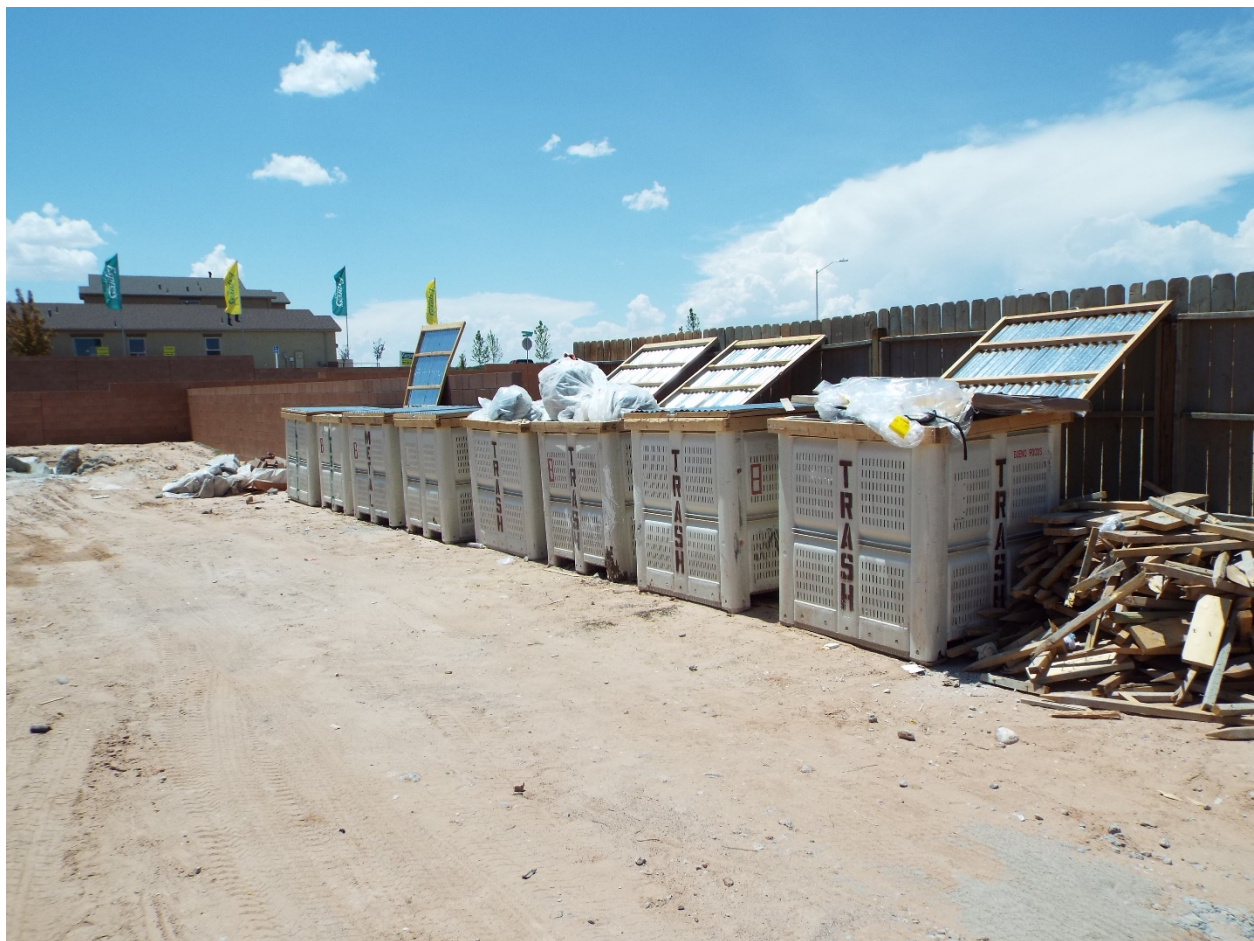
NMED/SWQB
Official Photograph Log
Photo #3

The operator has various trash bins provided for domestic waste; however; they need to be maintained so that they can be closed at the end of each business day.

The pile of construction debris left on the ground should also be stored in a waste container rather than placed on the ground as seen in the photo #3.

Photographer: Daniel Valenta	Date: July 19, 201	Time: 1321 Hours
City/County: Rio Rancho / Sandoval		State: New Mexico
Location: Enchanted Hills Subdivision / DR Horton Homes; Chayote and Valencia Road		
Subject: Trash bins

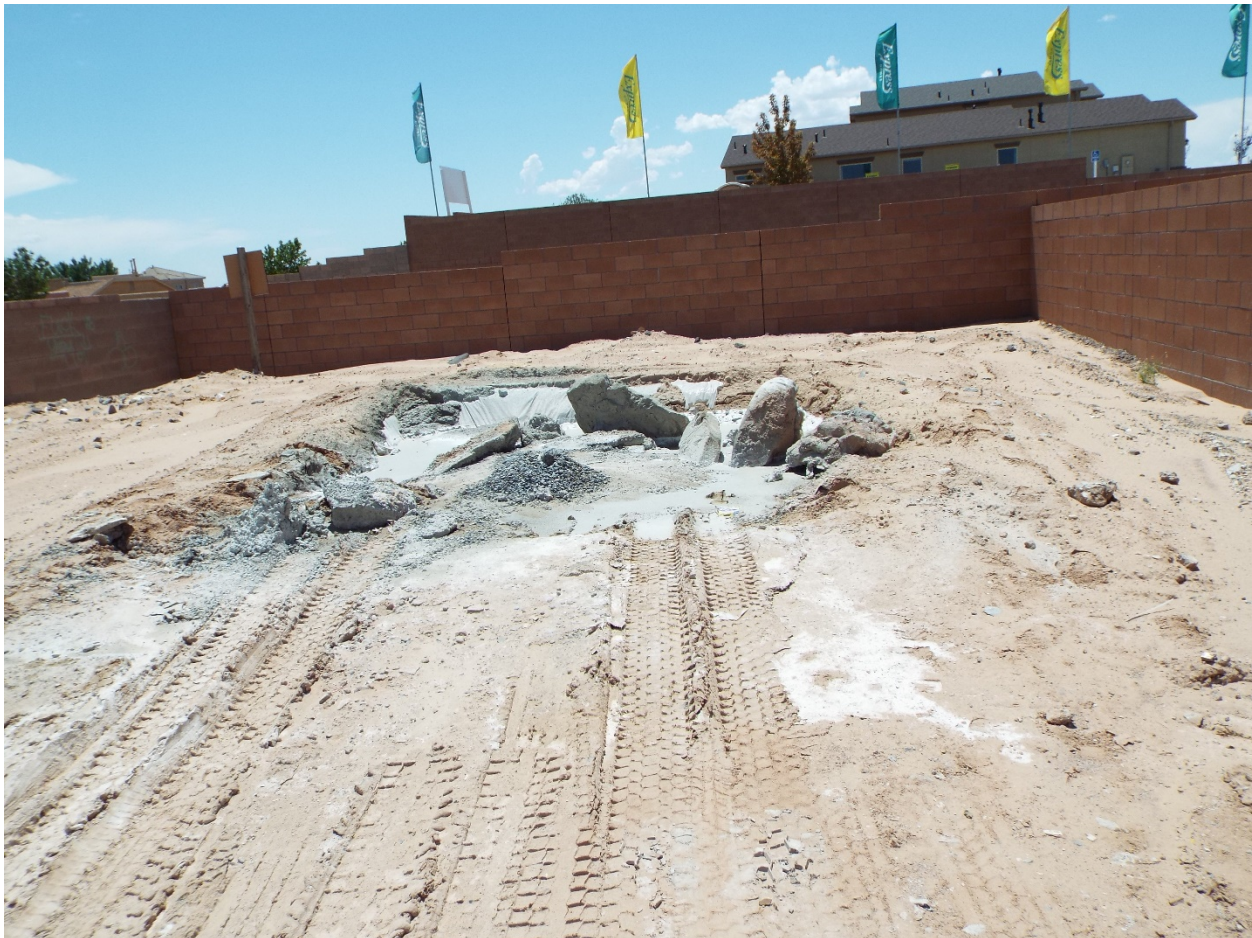
NMED/SWQB
Official Photograph Log
Photo #4

The concrete lined pit needs some maintenance as it is nearing capacity, along with solid pieces of concrete as shown in the photo #4.

Photographer: Daniel Valenta	Date: July 19, 201	Time: 1321 Hours
City/County: Rio Rancho / Sandoval		State: New Mexico
Location: Enchanted Hills Subdivision / DR Horton Homes; Chayote and Valencia Road		
Subject: Concrete Washout
